Preservation Case Studies

Improving Thermal Efficiency: Historic Wooden Windows

The Colcord Building
Oklahoma City, Oklahoma

Sharon C. Park AIA

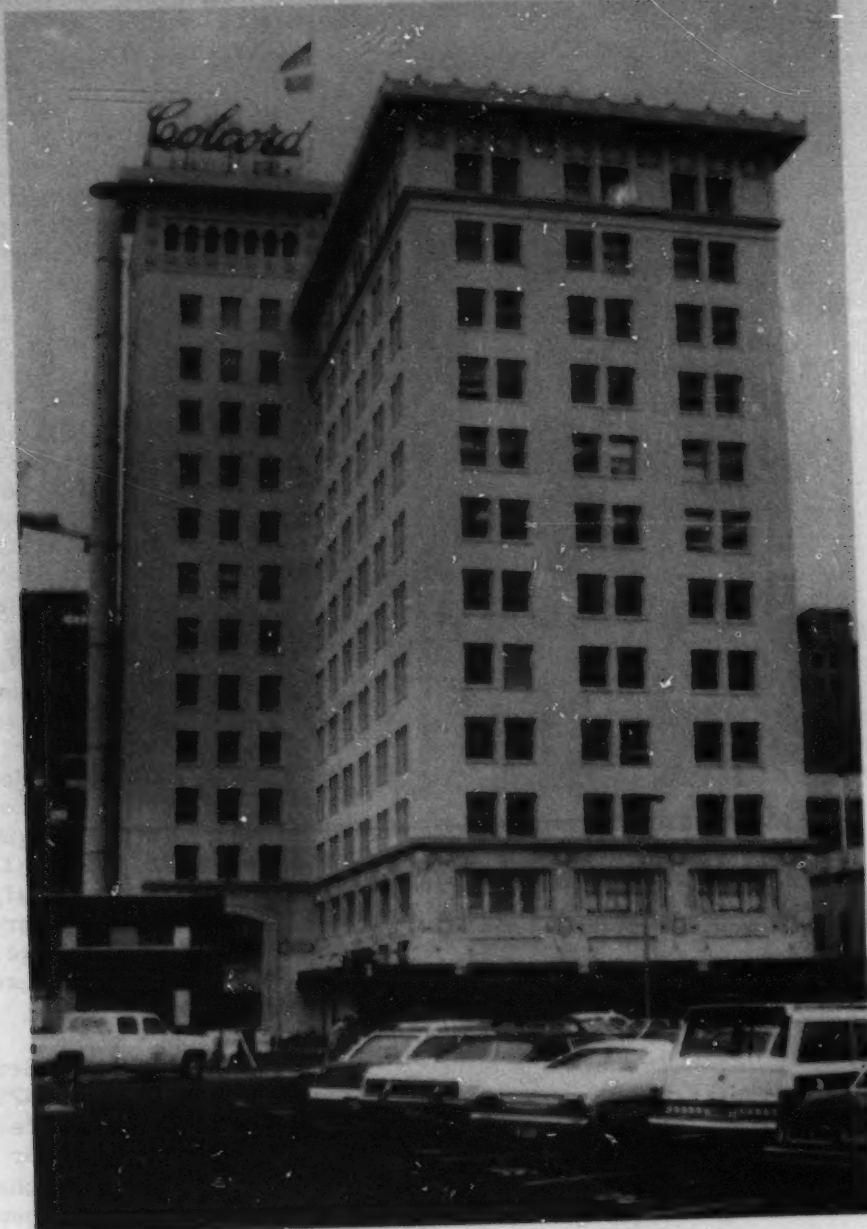
Figure 1. *The Colcord Building, Oklahoma City, Oklahoma. This 12-story poured-in-place concrete building with terra-cotta ornamentation was built in 1910 and is individually listed on the National Register of Historic Places. (Photo: H. Ward Jandl)*

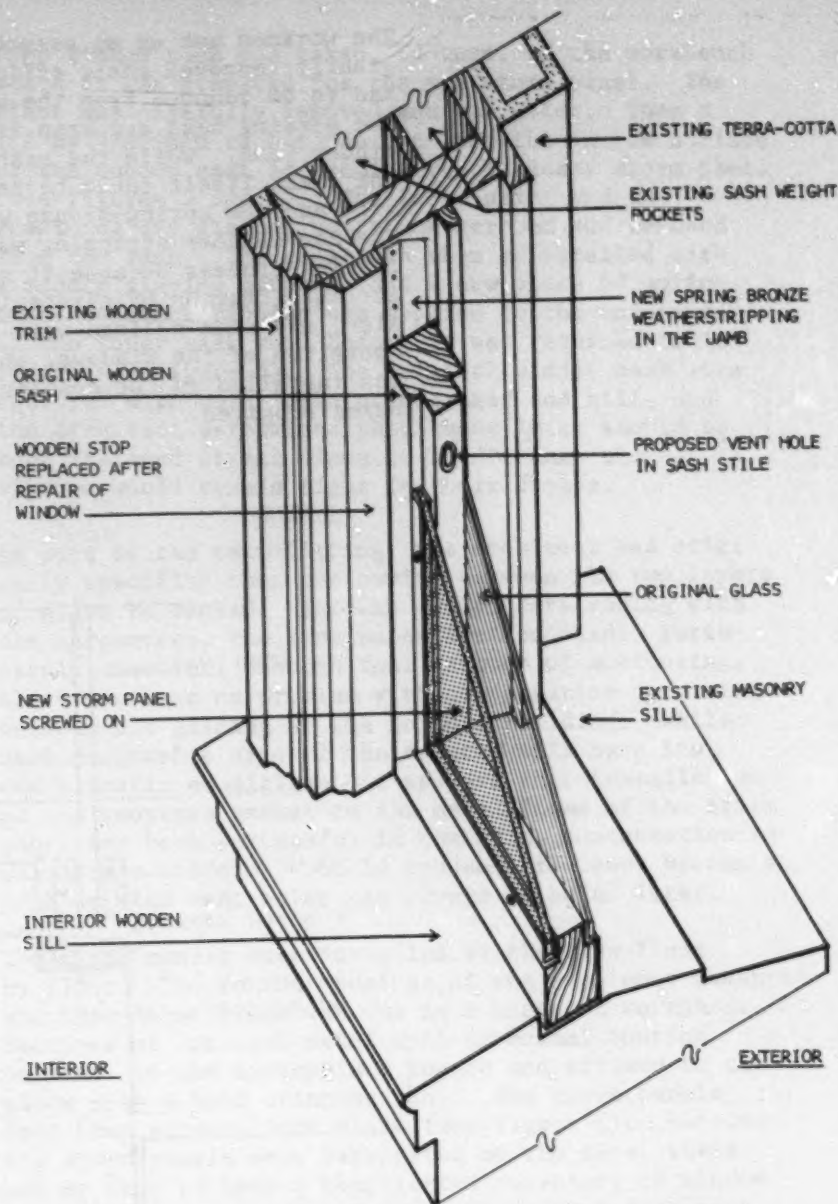
The architect's two concerns were the routing, or rabbeting, of the windows' wooden rails and stiles and the impact the additional weight of the storm panels would have on operating the windows. The cross-section of the sash rails and stiles was 1 7/8 by 2 inches of solid wood in good condition. The proposed rabbet of 1/2 by 3/8 inch was, therefore, not substantial enough to weaken the windows. This rabbeting would still allow a thermal cavity of a full inch between the glazing layers. The second concern was whether the existing sash weights could tolerate the additional weight of the storm panels. The Colcord Building windows vary from 22 by 66 inches to 48 by 66 inches and are composed of an upper and lower sash. The corresponding weight of the storm panels was approximately 3 to 8 pounds. The architect determined that the existing sash weights were adequate and specified that the pulleys of the sash chains be lubricated during the retrofitting to ease operating the heavier windows. (see figure 3)

Figure 3. Cutaway view of the window showing the proposed interior storm panel in place. Note the new weather stripping on the frame of the window and the proposed vent hole on the wooden sash stile.

moist air from penetrating into the cavity between the two layers of glazing. The vent holes, drilled laterally through the sash stiles, were to provide a minimum amount of circulation within the cavity to reduce condensation. (see figure 3)

Each window sash was taken, in turn, to the workbench where it was prepared for the new storm panel. The glass was carefully removed and set aside. Then a 1/2 by 3/8 inch rabbet was cut from the inside surface of the wooden sash to receive the recessed storm panel (see figures 3 and 4). The loose paint and any remaining dry glazing putty was scraped and removed from the sash. The glass was then reinstalled with a modern glazing compound and a new piece of spring metal weatherstripping was applied to the underside of the lower sash rail before it was returned to its frame (see figure 5). The original window sash were equipped with sash locks at the head and sill, and the architect determined that these locks should be kept fastened at all times to insure that the windows would remain tight in their frames.

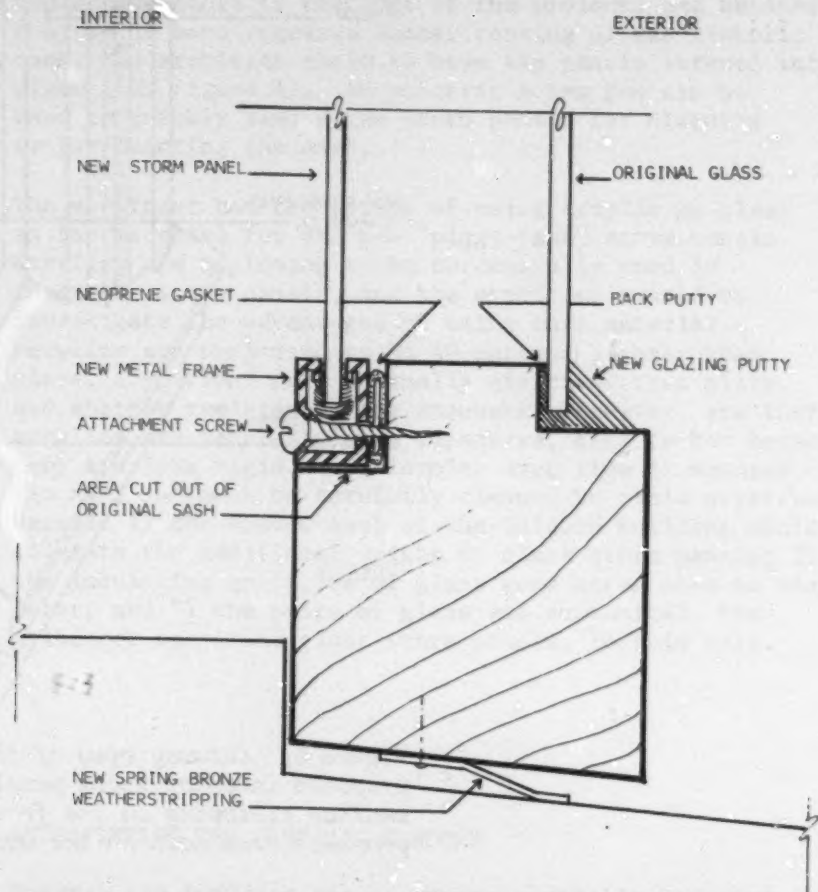
Figure 4. Detailed section through the wooden sash rail with storm panel in place. Note the small area of wood cut out to recess the new storm panel. The cavity left between the two glazing layers is 1 inch which is within the optimum range on $\frac{1}{4}$ inch to $1\frac{1}{4}$ inch for insulated glazing. Note the neoprene gasket that acts to seal out moist air between the storm panel and the wooden window.

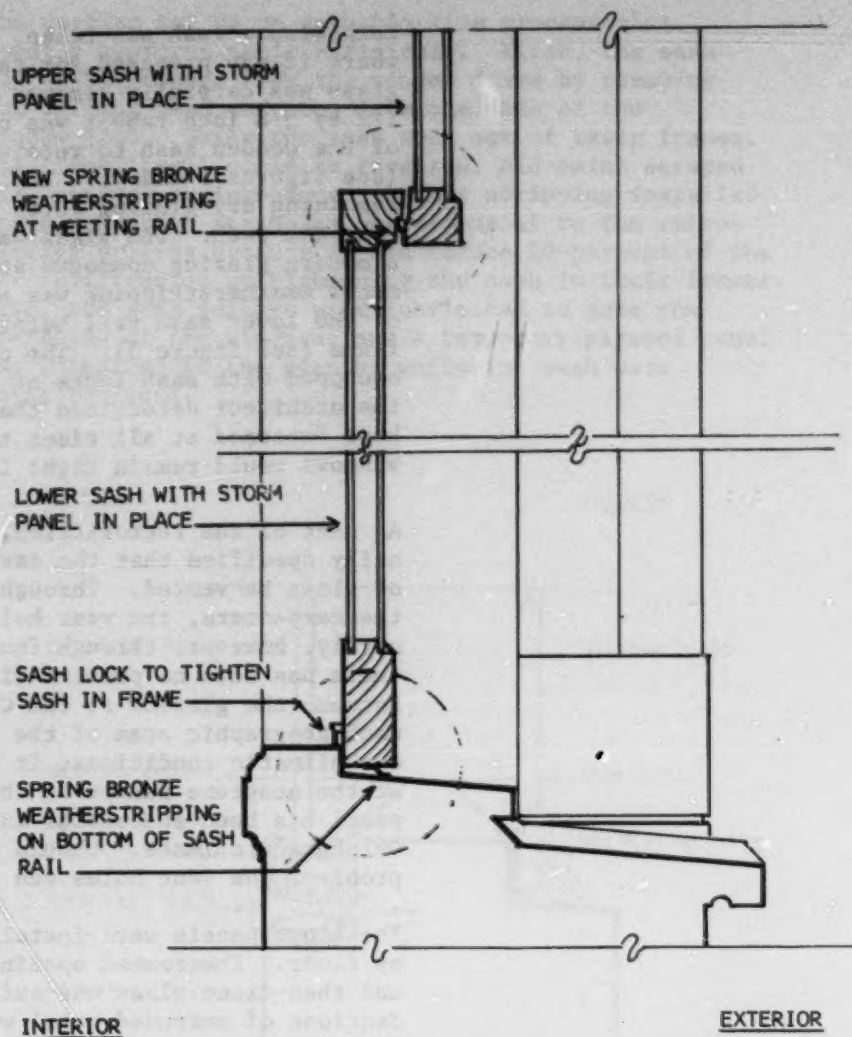
Figure 5. Section through the window showing areas of weather stripping. Note that new weather stripping was also added between the sash and the wooden frame, or jamb.

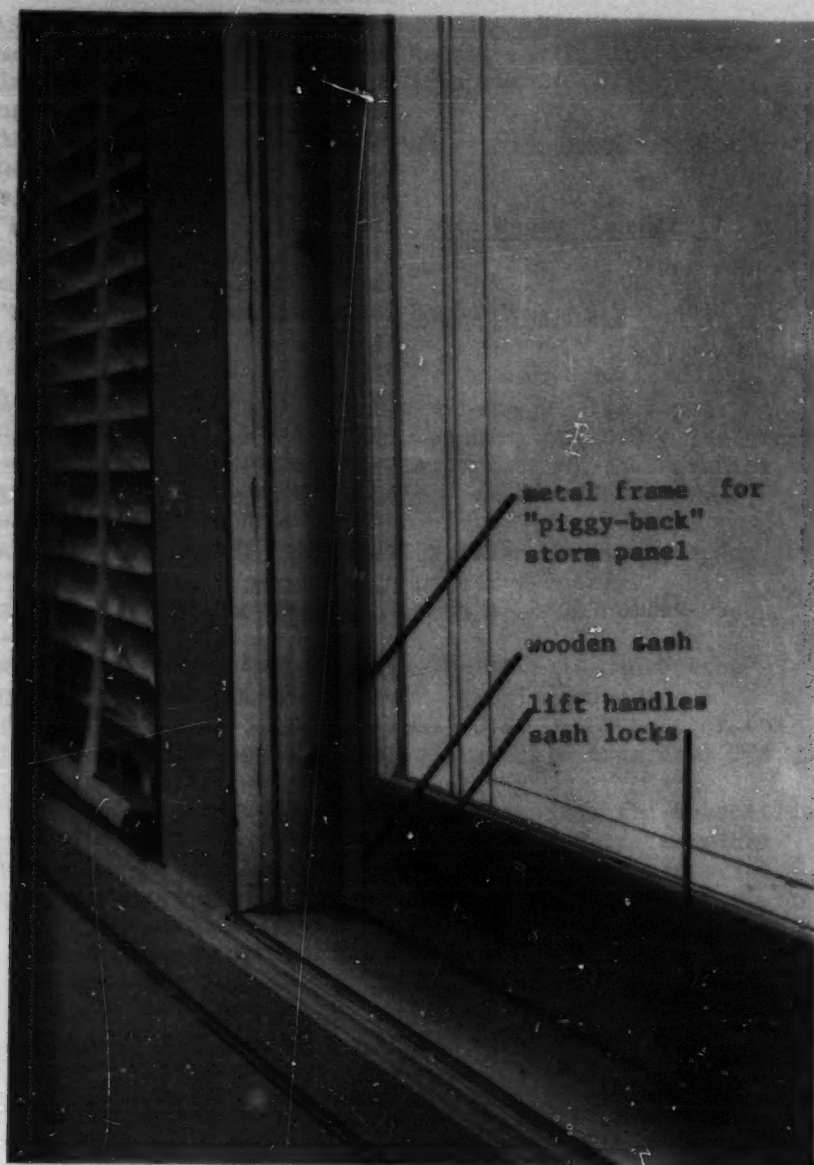
Figure 6. New interior storm panel in place. Note that the storm panel was recessed into the wooden sash. This allows full operability of the window as the lower sash is raised without hinderance from the storm panel on the upper sash. The interior storm panels were affixed with screws and will be removed only for maintenance. (Photo: Tamara Coombs)
